CHINA-BURMA BORDER AREA,  
MILITARY AND LOGISTICS  
STUDY UPDATE

# CHINA-BURMA BORDER AREA, MILITARY AND LOGISTICS STUDY UPDATE

AUGUST 1969

NATIONAL PHOTOGRAPHIC INTERPRETATION CENTER

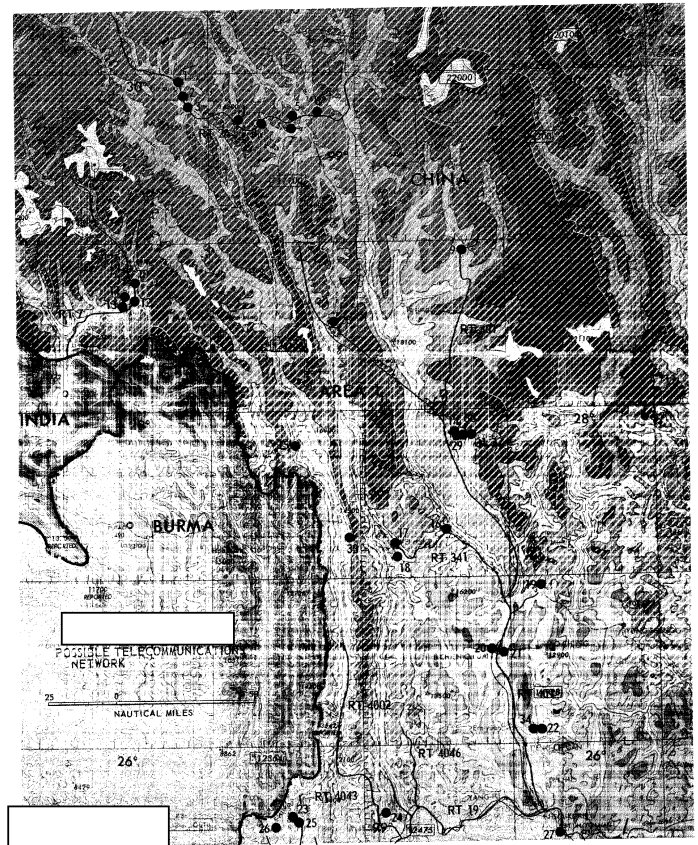
FIGURE 2. AREA 1

## AREA 1 (FIGURE 2)

Area 1 contains that portion of China north of 25-30N and within 100 nm of the Burma border. The main roads in this area are Route 19 (the Burma Road), which runs generally west from Kunming into the area of study; Route 401, which runs north from Hsiakuan; and Route 204, which runs across the northern portion of the search area. Route 204 was improved between [REDACTED]. There are no road crossings into Burma from Area 1; however, Route 4002 runs parallel to the border for 46 nm. Seven new facilities and one facility reflecting change are reported in Area 1.

Route 204 runs generally east-west across the top of the area of study and enters the area on the east at 29-46N 099-00E and the west at 30-10N 097-25E. In [REDACTED] the road was in good condition from the eastern edge to 29-43N 098-49E and in poor condition and undergoing improvement from there to the western edge. The reconstruction was completed in [REDACTED] and the road was in good condition. There has been no subsequent coverage.

Route 7 runs south along the northwest edge of the area of study and enters the area at 29-03N 097-22E and 28-37N 097-22E. The road is in fair-to-good condition; there has been no major change since [REDACTED].

Route 401 runs north from Hsiakuan (25-36N 100-13E) to the edge of the area of study at 29-04N 099-51E. The road is in fair-to-good condition; there has been no major change since [REDACTED]. An unnumbered road runs northwest from Route 401 at 27-50N 099-43E to 28-58N 098-38E. This road is in good condition; there has been no major change since [REDACTED].

Route 341 runs generally northwest from its junction with Route 401 at 26-52N 099-58E to 27-13N 099-17E. The road is in fair-to-good condition; there has been no major change since [REDACTED].

Route 4002 runs generally north from 25-27N 099-15E, parallel to the Burma border, to 26-37N 098-54E. The road is in good condition; there has been no major change since [REDACTED].

Route 4046 runs north from its intersection with Route 19 at 25-36N 099-19E to 26-03N 099-19E. [REDACTED] the terminus was at 25-54N 099-20E. [REDACTED] the road was being improved over its entire length and being extended to its present terminus at 26-03N 099-19E.

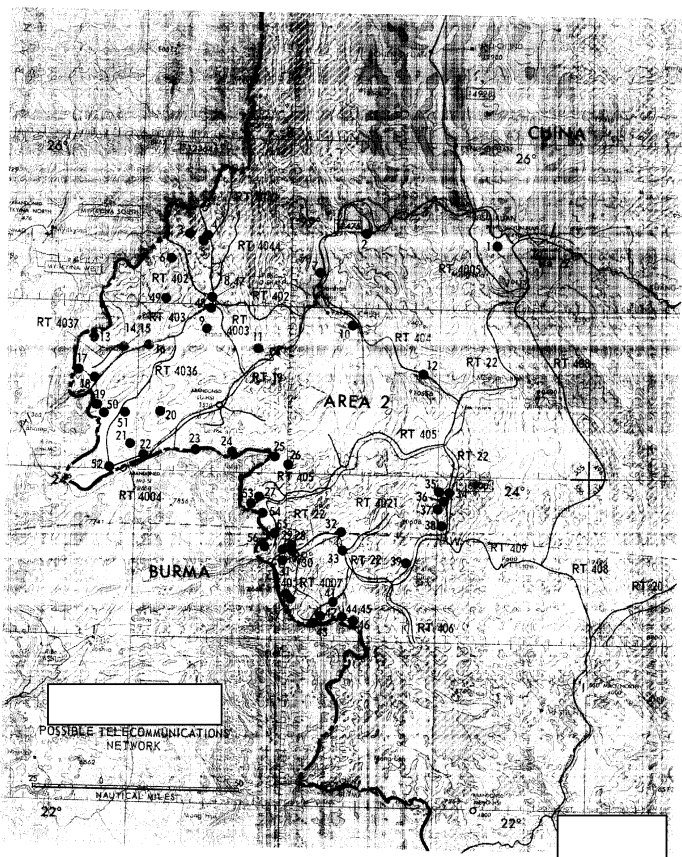
FIGURE 3. AREA 2

## AREA 2 (FIGURE 3)

Area 2 contains that portion of China between 23-30N and 25-30N and within 100 nm of the Burma border. The main roads in this area are Route 19, which enters from Area 1, leads toward Burma, and crosses the border at Wanting; Route 22, which runs southwest from Route 19 to within 10 nm of the Burma border; and Route 405, which runs west from Route 22 toward the Burma border and is presently being extended. Route 19 is the only road that crosses into Burma. Eleven new facilities and five facilities reflecting change are reported in Area 2.

Route 19 is the primary road in the study area. It crosses Yunnan Province through Kunming and Hsiakuan to the Burma border at Wanting, enters Area 2 at 25-26N 100-28E, and crosses into Burma at 24-05N 098-04E. The road is in good condition in both China and Burma; there has been no major change since [ ] An unnumbered road runs south from Route 19 at Luhsi (24-25N 098-34E), then southwest to 24-17N 098-26E. The road is in good condition; there has been no major construction [ ] An unnumbered road is under construction south from Route 19 to the Burma border. It intersects Route 19 at 24-15N 098-16E and terminates at 24-06N 098-18E. The road was first observed under construction in [ ] and construction was still in progress in [ ] There has been no subsequent coverage. In [ ] four construction camps were observed. The first, at 24-10-40N 098-12-20E, contained 50 buildings; the second, at 24-10-20N 098-12-30E, contained five buildings; the third, at 24-09-50N 098-12-40E, contained 12 buildings, and the fourth, at 24-09-00N 098-13-20E, contained 22 buildings. Another unnumbered road under construction runs generally east from Route 19 at Luhsi (24-25N 098-34E) then southeast to its terminus at 24-20N 098-58E. This road has been under construction since [ ] and will probably join an unnumbered road running north from Route 405 to provide another access route to Nansan.

Route 4005 runs southeast from Hsiakuan (25-35N 100-13E) to Route 22 at 25-03N 100-32E. The road is in fair-to-good condition; there has been no major change since [redacted]

Route 4043 runs north from its intersection with Route 402 at Teng-chung (25-01N 098-29E) to 25-45N 098-33E, 4.5 nm from the Burma border. Between [ ] the road was extended from 25-42N 098-34E to its present terminus. The road is in fair condition; there has been no other major construction since [ ]. An unnumbered road runs north-northwest from Route 4043 at 25-21N 098-28E to 25-33N 098-23E. In [ ] the road was being extended 1.5 nm to its present terminus. This construction was not complete in [ ]; there has been no

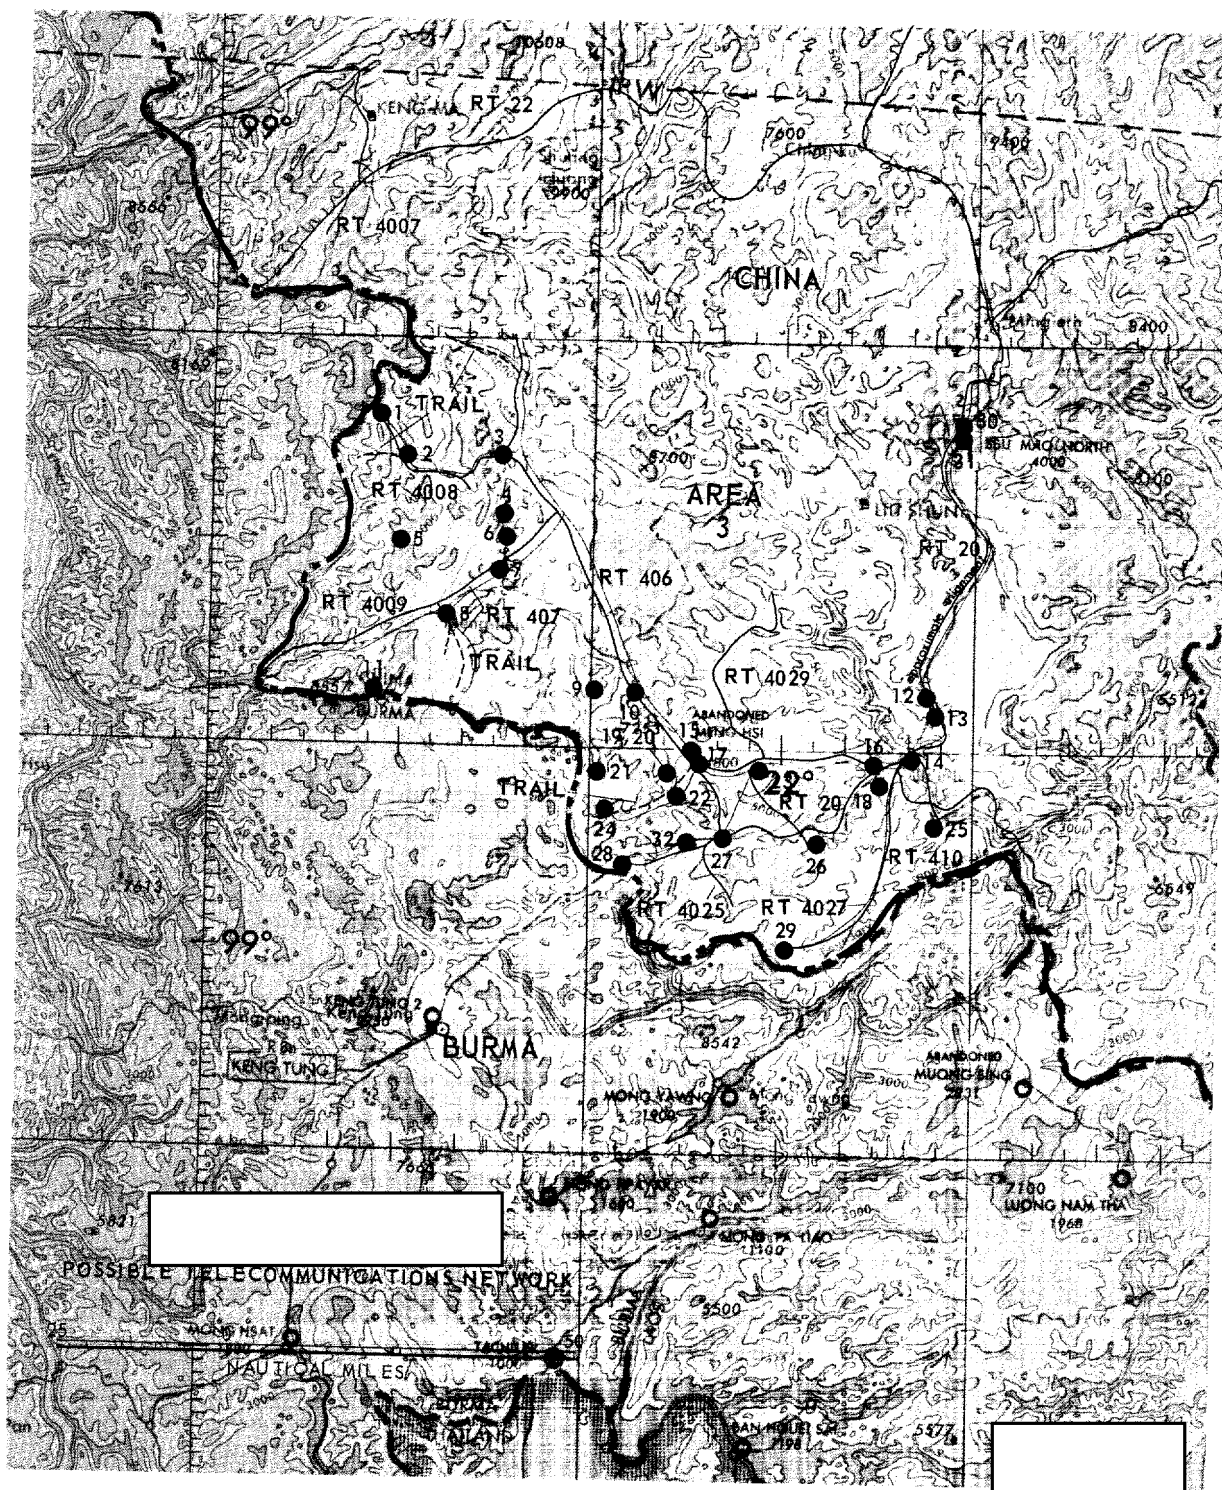
FIGURE 4. AREA 3

## AREA 3 (FIGURE 4)

Area 3 contains that portion of China south of 23-30N and within 100 nm of the Burma border. The main roads in this area are Route 20, which runs from Kunming to Talo on the Burma border and is being improved, and Route 406, which connects Routes 20 and 22. Three new facilities and one facility reflecting change are reported in Area 3.

Route 20 runs generally southwest from Kunming, enters the area of study at 21-50N 101-10E, and extends to Talo (21-41N 100-02E), 1 nm from the Burma border. [REDACTED] the road was in good condition from Kunming to Menghun (21-49N 100-23E), and was in poor-to-fair condition from Menghun to Talo. This last segment of road was being improved in [REDACTED]. Construction activity was still evident on the most recent coverage of [REDACTED] and two construction camps were observed. The first, at 21-46-50N 100-17-40E, contained four buildings and the second, at 21-46-15N 100-14-20E, contained eight buildings. An unnumbered road is under construction south from Route 20 at 22-01N 100-43E to Kanlanpa (21-50N 100-55E). This road was first observed under construction in [REDACTED] and construction continued in [REDACTED].

Route 406 runs generally south-southeast from its intersection with Route 22 at 23-23N 099-41E to its intersection with Route 20 at 21-56N 100-20E. The road is in good condition; there has been no construction
